Compilation of snapshots from videos Ex 60, 62, and 63 showing a consistent plumb of pulverized and fractured glass “down range” along the track of the bullet.

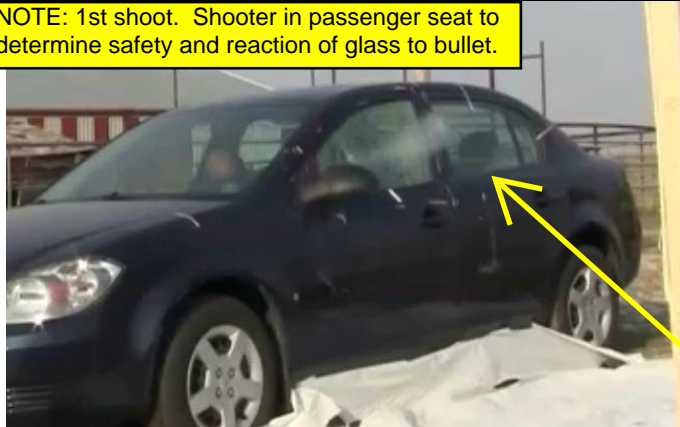
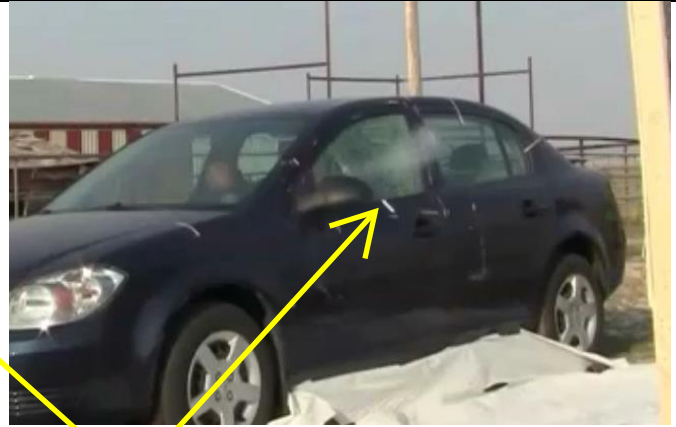
NOTE: 1st shoot. Shooter in passenger seat to determine safety and reaction of glass to bullet.

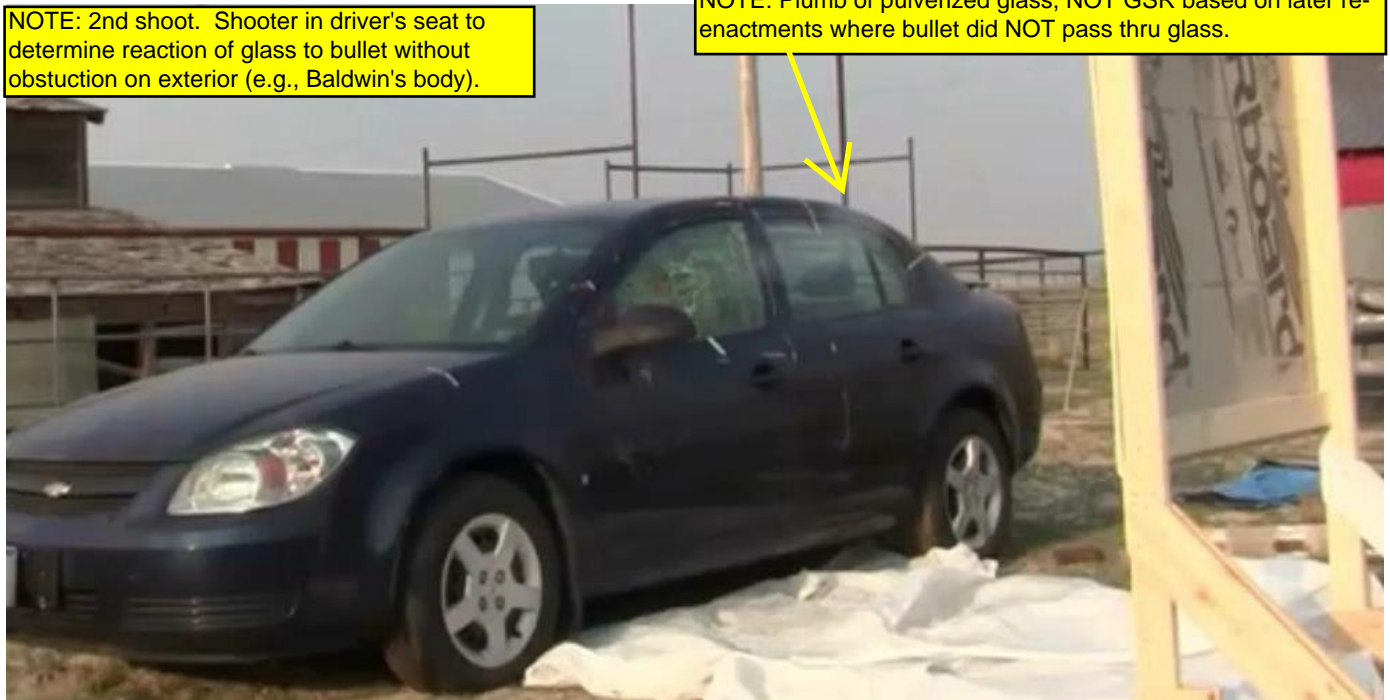
NOTE: 2nd shoot. Shooter in driver's seat to determine reaction of glass to bullet without obstruction on exterior (e.g., Baldwin's body).

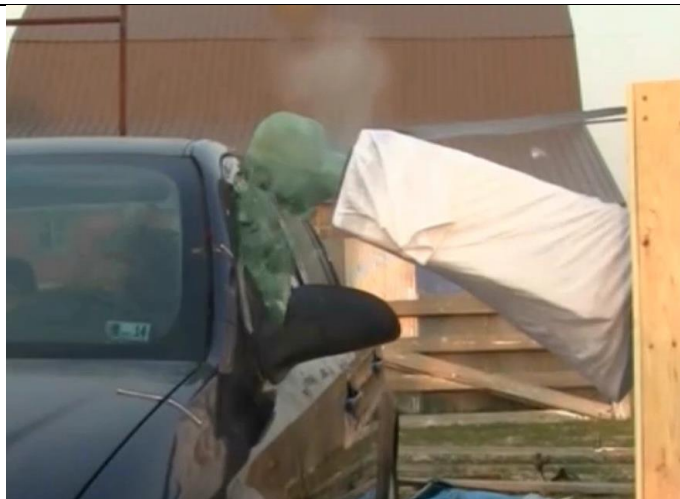
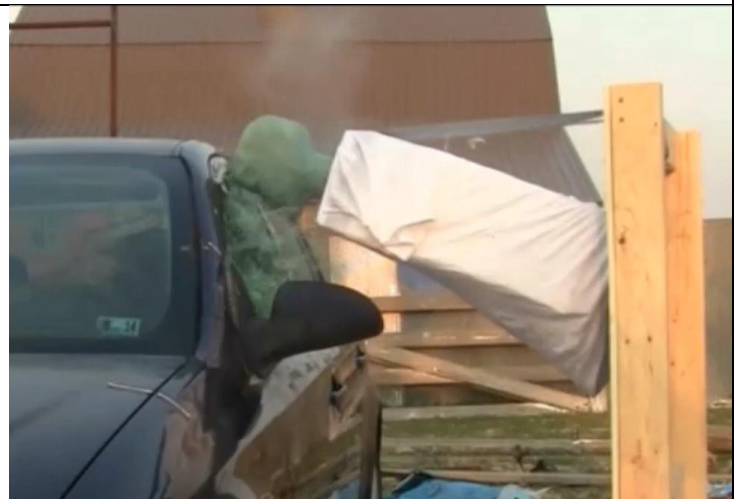
NOTE: Plumb of pulverized glass, NOT GSR based on later re-enactments where bullet did NOT pass thru glass.

NOTE: 3rd shoot. Shooter in driver's seat to determine reaction of glass to bullet if Baldwin was outside with face close to window at time of shot under State's theory at trial.
